Massachusetts State Police

Collision Reconstruction Report

CASE #	2022-CAR-000086
Related Case#

Commonwealth of Massachusetts
Collision Analysis and Reconstruction Section 2022-CAR-000086
Collision Reconstruction Report

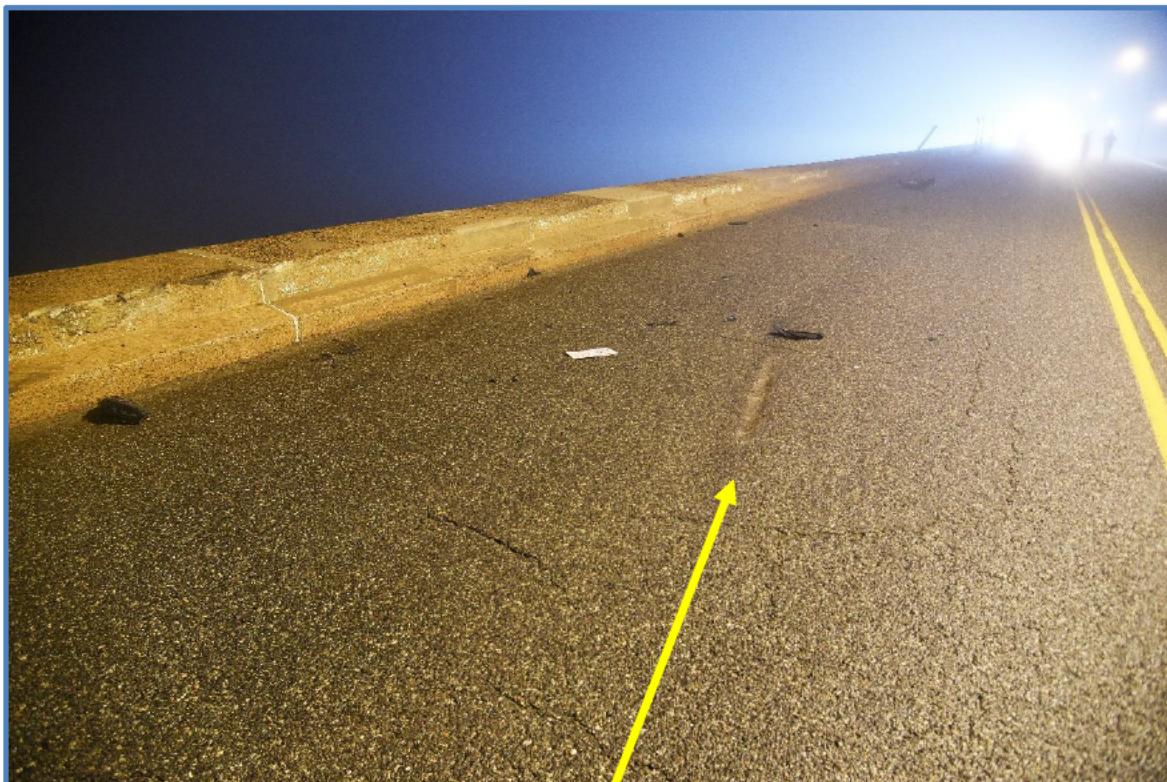
11. Located in the approximate center of the westbound travel lane, I observed a pavement scar running generally southwest to northeast. This mark was approximately 4.9 feet in length and had diagonal striations in the form of scrapes and gouges. The scrape/gouge was bordered by an amorphous tire mark. This pavement scar was consistent with a rotating tire sliding sideways, with the rim of the tire digging violently into the pavement. This type of scarring is consistent with a vehicle in an uncontrolled rotation and generally precipitates a rollover event when the tire catches the pavement and trips the vehicle.

Photo 1 – Tire Gouge/Scrape (Pierce)

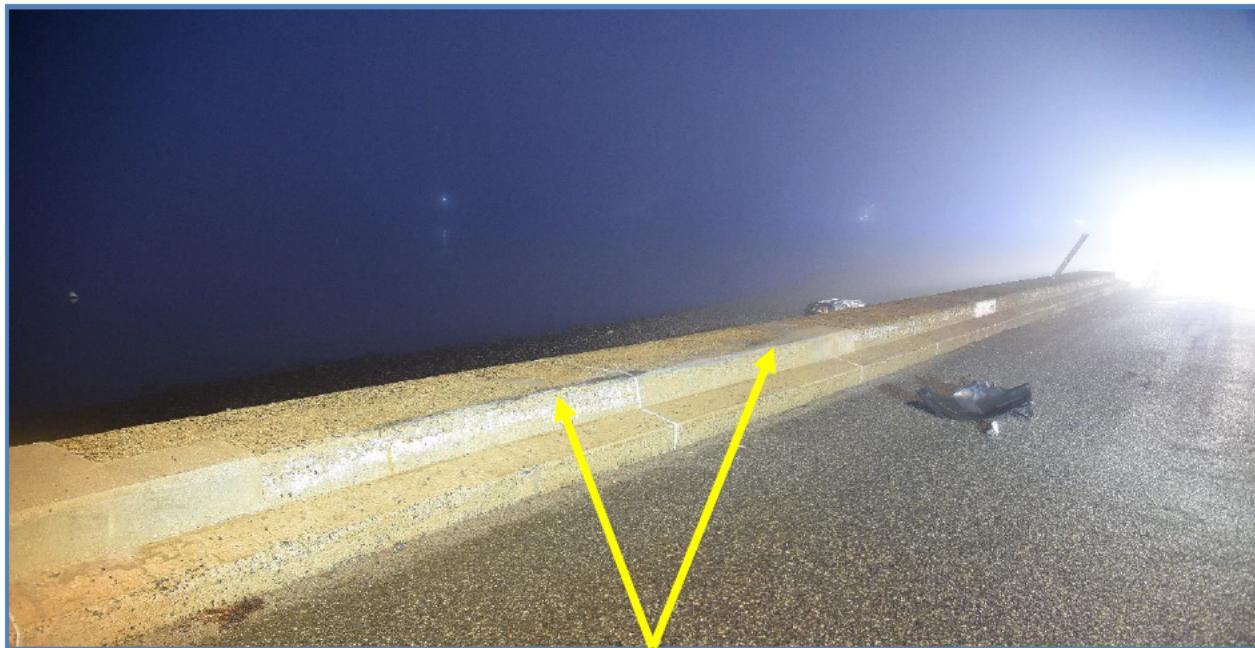
10. Atop Ocean Avenue, I observed several tire marks of varying lengths. These marks spanned a distance of approximately 70 feet, starting in the westbound travel lane and ending at the edge of the short wall bordering the roadway. These marks were generally located along the edges of the curb and wall and are best described as scuff marks. These marks had vertical striations and were accompanied by scrape marks, consistent with a rotating tire sliding along the concrete edge.

Photo 2 – Tire Marks (Pierce)

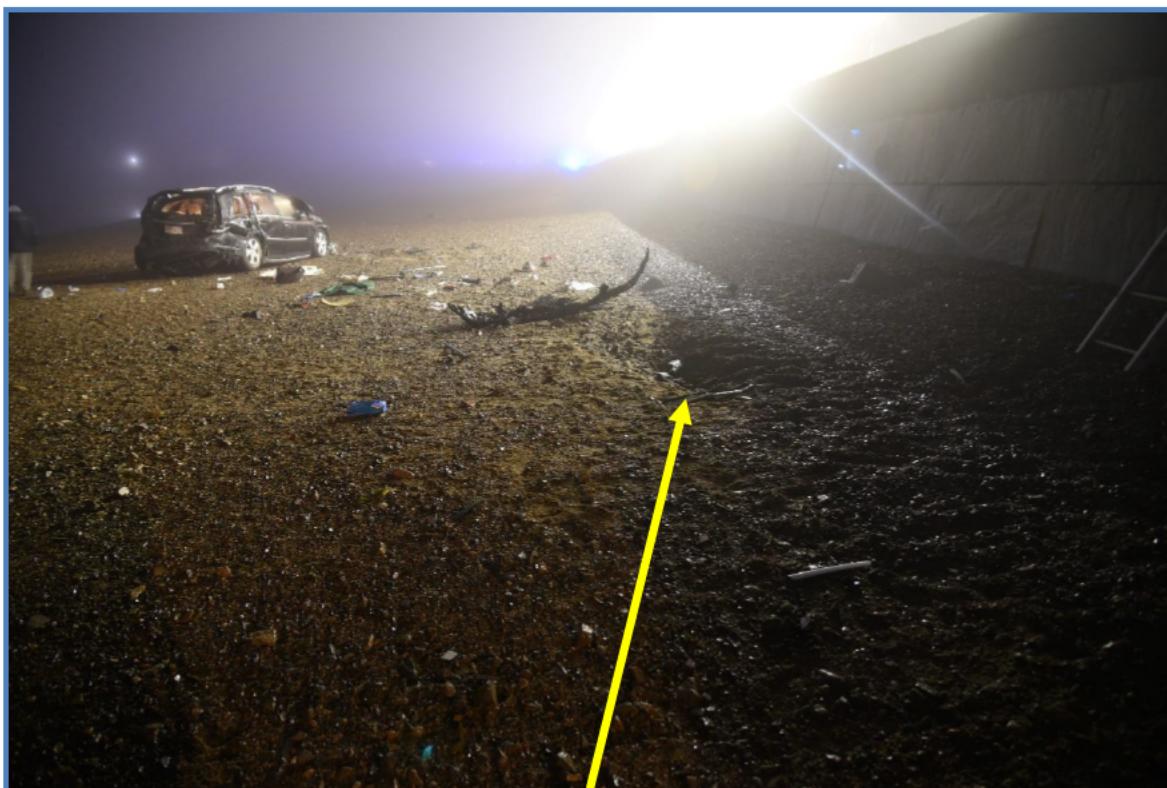
9. From the area of the vehicle at final rest, I observed an unabated trail of physical evidence that proceeded in a westerly direction. This evidence consisted of tire marks, scrapes, gouges, ruts, and vehicle debris. To the west of the Mercedes, I observed several deep ruts in the soft material of the beach. These ruts ranged in approximate length from 3 feet to 15 feet and generally led in a westerly direction, toward the retaining wall supporting the elevated roadway.

Photo 4 – Gouge (First Touch) (Pierce)

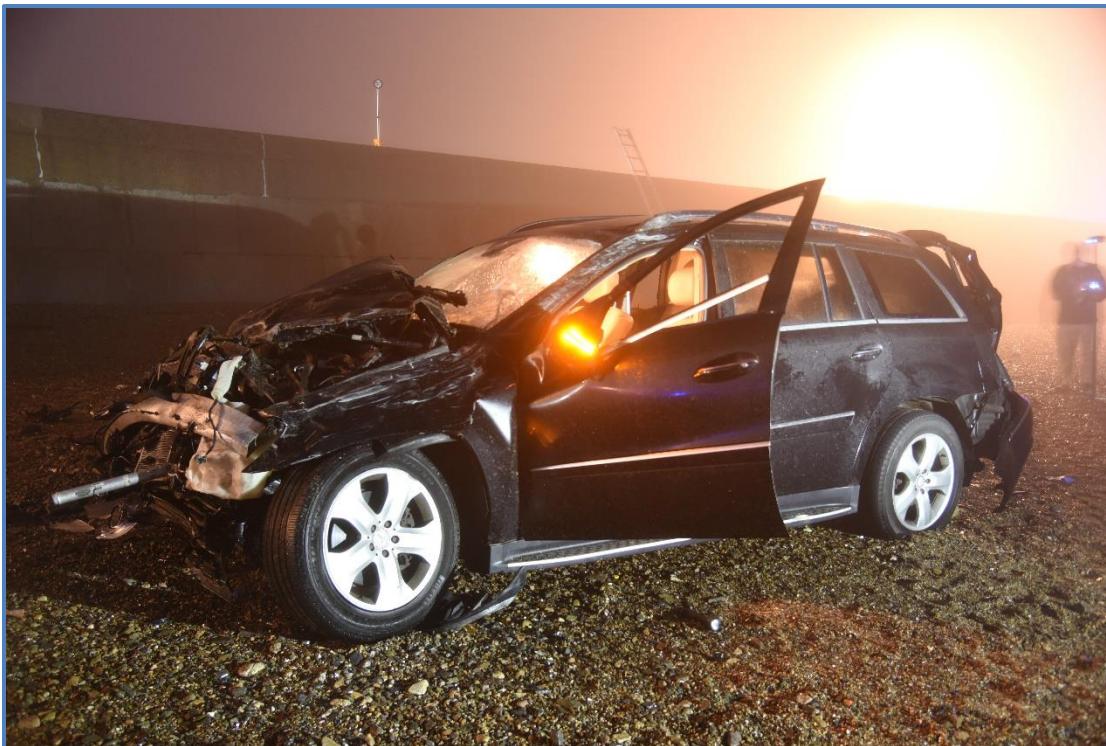
Photo 5 - Left Side (Pierce)

A. Exterior – The Mercedes had contact damage on all sides, consistent with a rollover crash. There was significant crush on the front end, resulting in the bumper, hood, and engine compartment being pushed back and the headlight assemblies destroyed. I observed scrapes along the top of the left front fender and “A” pillar. There was also significant contact damage on the right rear corner and rear hatch of the vehicle. I observed multidirectional scrapes along the right side roof edge. The contact areas had substantial coverings of sand and grit. Due to the lack of contact damage on the roadway

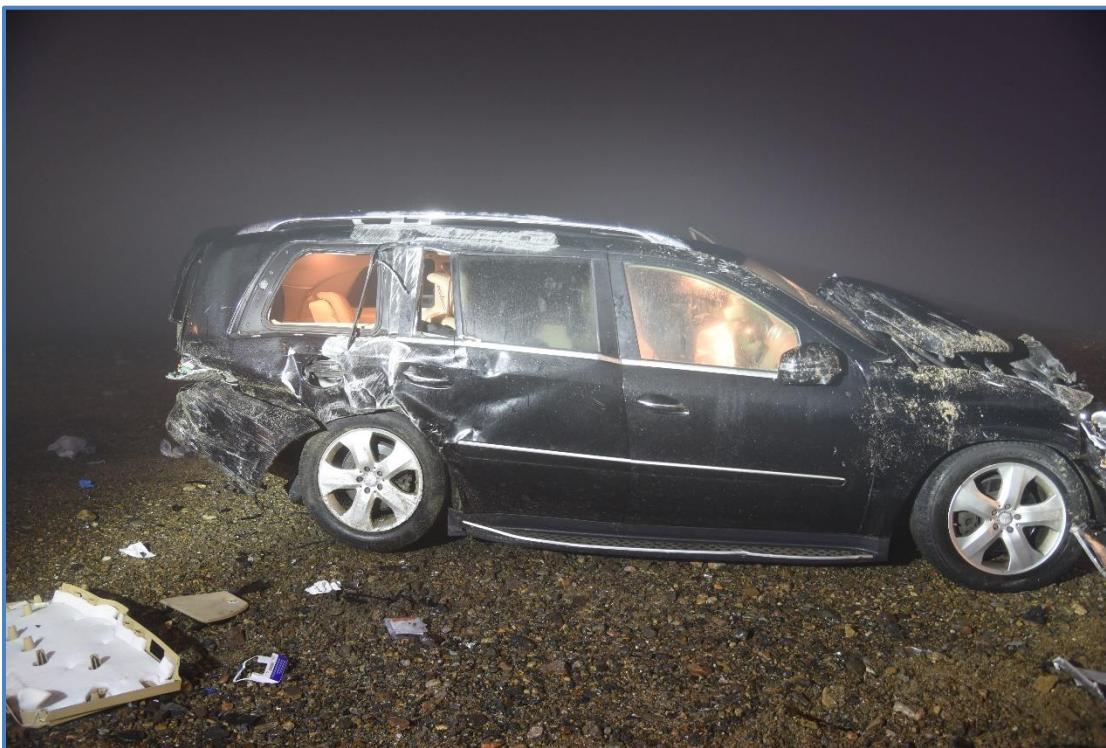
Photo 6 - Right Side (Pierce)

D. Tires, Rims, and Brakes – The vehicle was equipped with four disc brakes, which were visually inspected on scene. The rotors were in good condition and the brake pads appeared to be of adequate thickness. The right rear tire was flat, and the rim had significant contact damage on the surface and edges. I observed no comparable contact damage on any of the remaining three tires or rims. I therefore concluded that the scrape/gouge observed on the roadway (as described in Paragraph 11) was most likely made by the right rear tire.

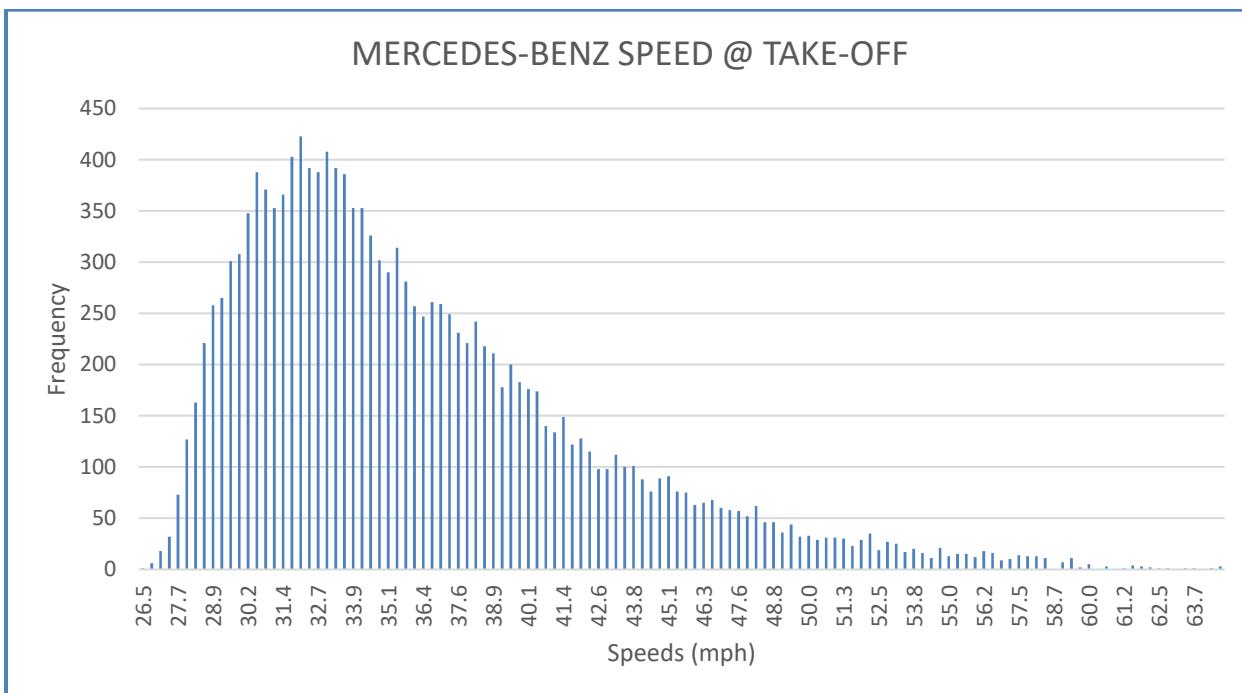
29. Using an MS Excel spreadsheet, the speed of the Mercedes at take-off was calculated 15,000 times. Each calculation was done with randomly generated numbers for each variable. The resultant statistical calculations found the mean (average) speed to be approximately 36.1 mph, with a standard deviation of 6.19. The range of most likely speeds (i.e., speeds calculated between the 24th and 76th percentile) was found to be within approximately 31.4 mph to 39.3 mph. These calculations are represented graphically as the following:

30. Based on this statistical analysis, I determined that Mercedes speed at take-off was most likely approximately 36 mph. This analysis does not factor in speed loss from the tires striking the curb, and therefore represents a minimum speed calculation of the vehicle at take-off. Furthermore, this analysis does not account for braking and/or speed loss from rotation, and therefore does not represent an accurate speed of the Mercedes prior to the operator's loss of control.
