Massachusetts State Police

Collision Reconstruction Report

CASE #	2022-CAR-000086
Related Case#

Commonwealth of Massachusetts
Collision Analysis and Reconstruction Section 2022-CAR-000086
Collision Reconstruction Report

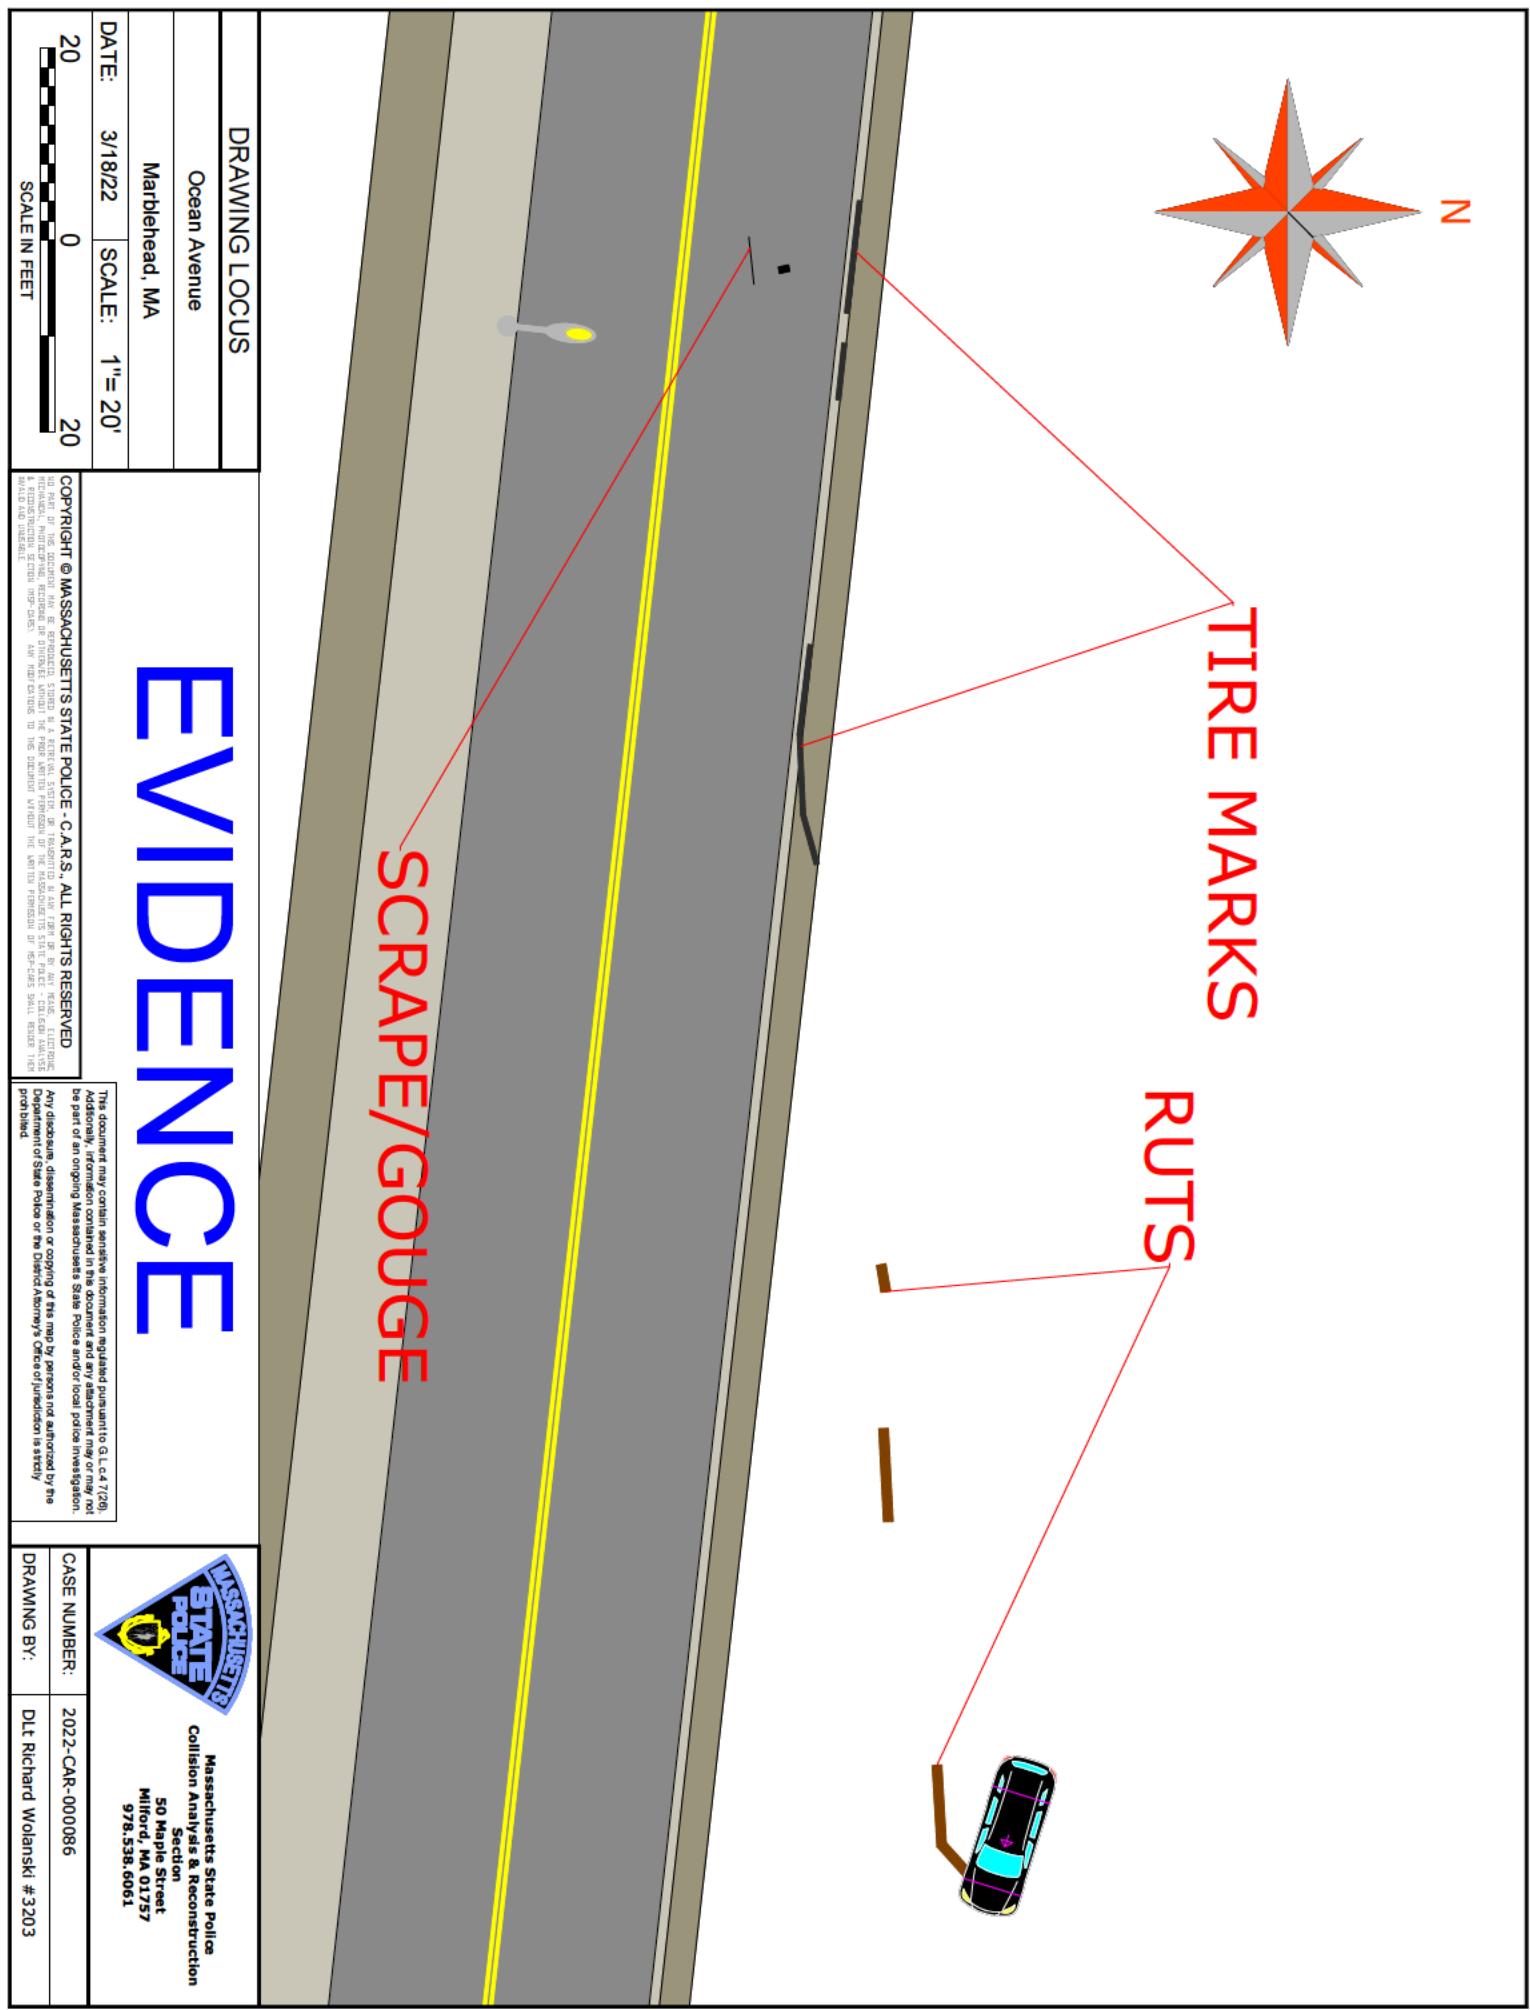
PRE-IMPACT

- A. A 2011 Mercedes-Benz GL450 was traveling eastbound on Ocean Avenue on March 18, 2022.
- B. The Mercedes was operated by the sole occupant of the vehicle, James Galante. He was not wearing his seatbelt at the time of the crash.
- C. Galante entered a hard left steering input and lost operational control of the Mercedes. The vehicle entered into an uncontrolled counter-clockwise rotation and subsequently exited the roadway at a statistically-likely speed of approximately 36 mph, above the posted speed limit of 30 mph.
